CARE HOMES / SENIOR LIVING

WARM WATER TREATMENT IN SENIOR CITIZENS HOME WITH APPROX. 90 BEDS

Aquadron FXM

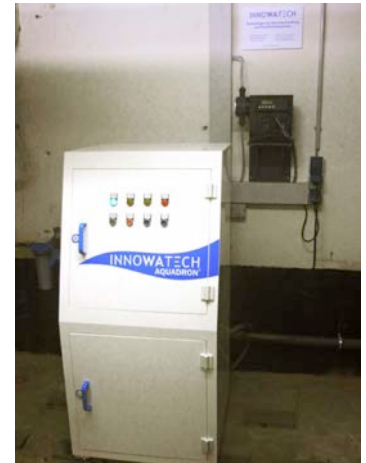
Hot water consumption about 5m³/d.

Pipe material: galvanized steel.

Extensive thermal disinfection was used with only moderate success, low hot water consumption, stagnation.

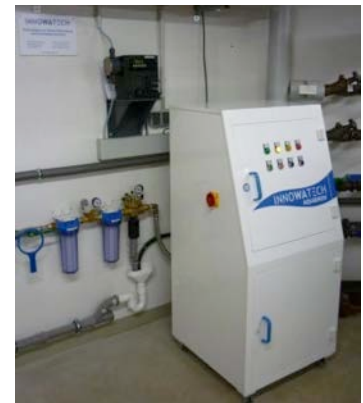
WARM WATER TREATMENT IN NURSING HOME WITH 120 BEDS

Aquadron FXM

Hot water consumption about 6m³/d.

Pipe material: stainless steel, plastic.

Wide branched pipe system, stagnation, thermal hot water treatment required high demand for energy and personnel.

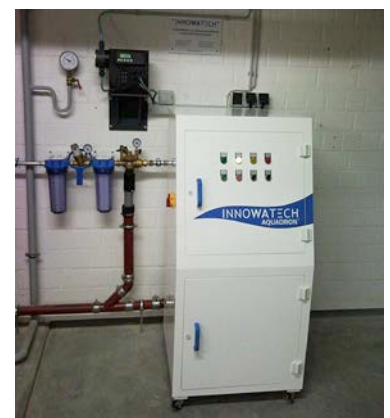
WARM WATER TREATMENT IN SENIOR CITIZENS HOME WITH APPROX. 60 PLACES

Aquadron FXM

Hot water consumption about 5m³/d.

Pipe material: galvanized steel.

Oversized piping system, stagnation, high energy requirement for hot water temperatures > 60°C, scald risk was a problem.

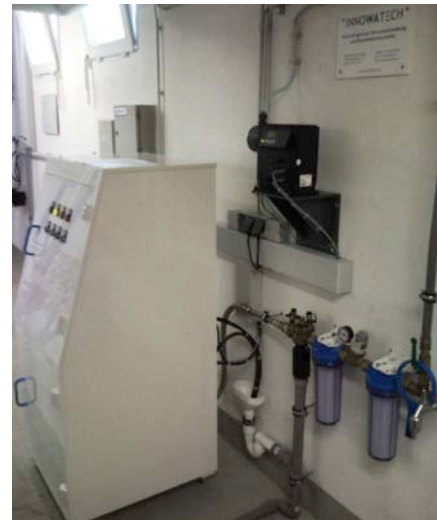
WARM WATER TREATMENT IN NURSING HOME WITH APPROX. 130 PLACES

Aquadron FX

Hot water consumption about 6m³/d.

Pipe material: galvanized steel.

Hot water installation was thermally treated to protect against microbiological contamination each week at 70 ° C, high energy requirement, heat was also transferred to the cold water pipes, meaning high cold water temperatures, scald risk was a problem.

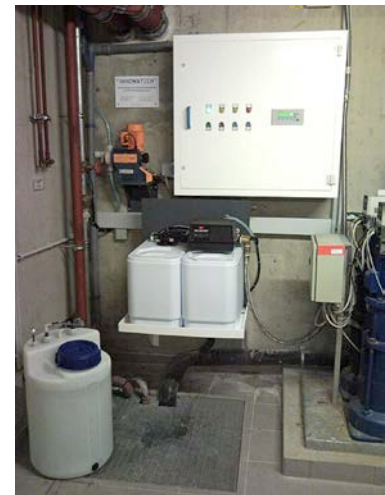
WARM WATER TREATMENT IN A SENIOR RESIDENTIAL WITH CA. 220 ASSISTED LIVING PLACES AND 50 EXTRA CARE BEDS

Aquadron FXL

Hot water consumption of approximately 25m³/d.

Pipe material: galvanized steel, stainless steel.

Corrosion problems due to high hot water temperature in galvanized pipe system, widely branched pipe system with deadlegs.

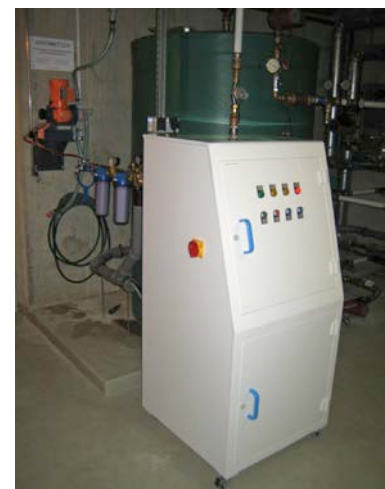
WARM WATER TREATMENT IN CARE HOME WITH APPROX. 55 BEDS

Aquadron FX

Hot water consumption about 5m³/d.

Pipe material: plastic.

Extensive thermal disinfection was used with only moderate success, low hot water consumption, stagnation.

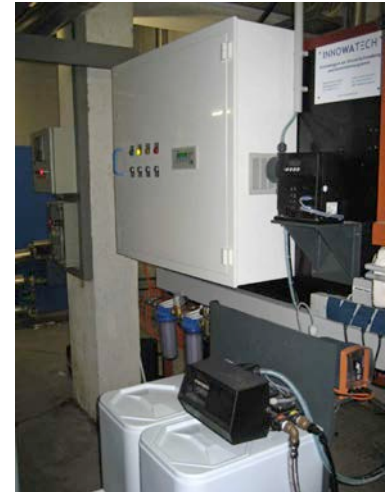
WARM WATER TREATMENT IN AN OLD AND NURSING HOME WITH APPROX. 150 ASSISTED LIVING APARTMENTS AND 135 BED CARE FACILITY

Aquadron FXL

Hot water consumption of approximately 35m³/d.
Pipe material: galvanized steel, stainless steel.

Branched, oversized lines, stagnation, thermal hot water treatment required high demand for energy and personnel, corrosion problems due to high hot water temperature in galvanized piping.

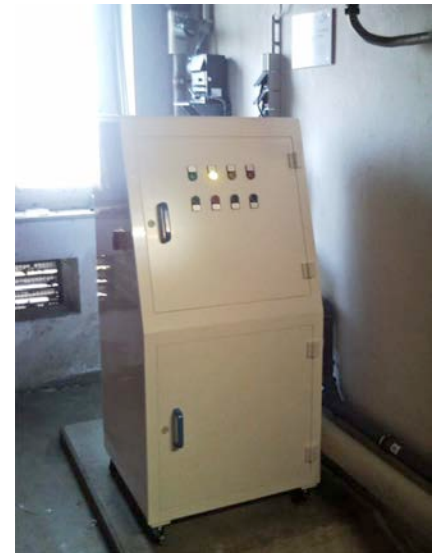
WARM WATER TREATMENT IN NURSING HOME WITH APPROX. 35 BEDS

Aquadron FXM

Hot water consumption about 3m³/d.
Pipe material: galvanized steel.

Old pipeline system, thermal disinfection with only moderate success, low hot water consumption, stagnation.
